13 December 2024

Kent Cook  
Citify Group

## **RE: Buckingham Arms Hotel – Post-Fire Event Structural Assessment**

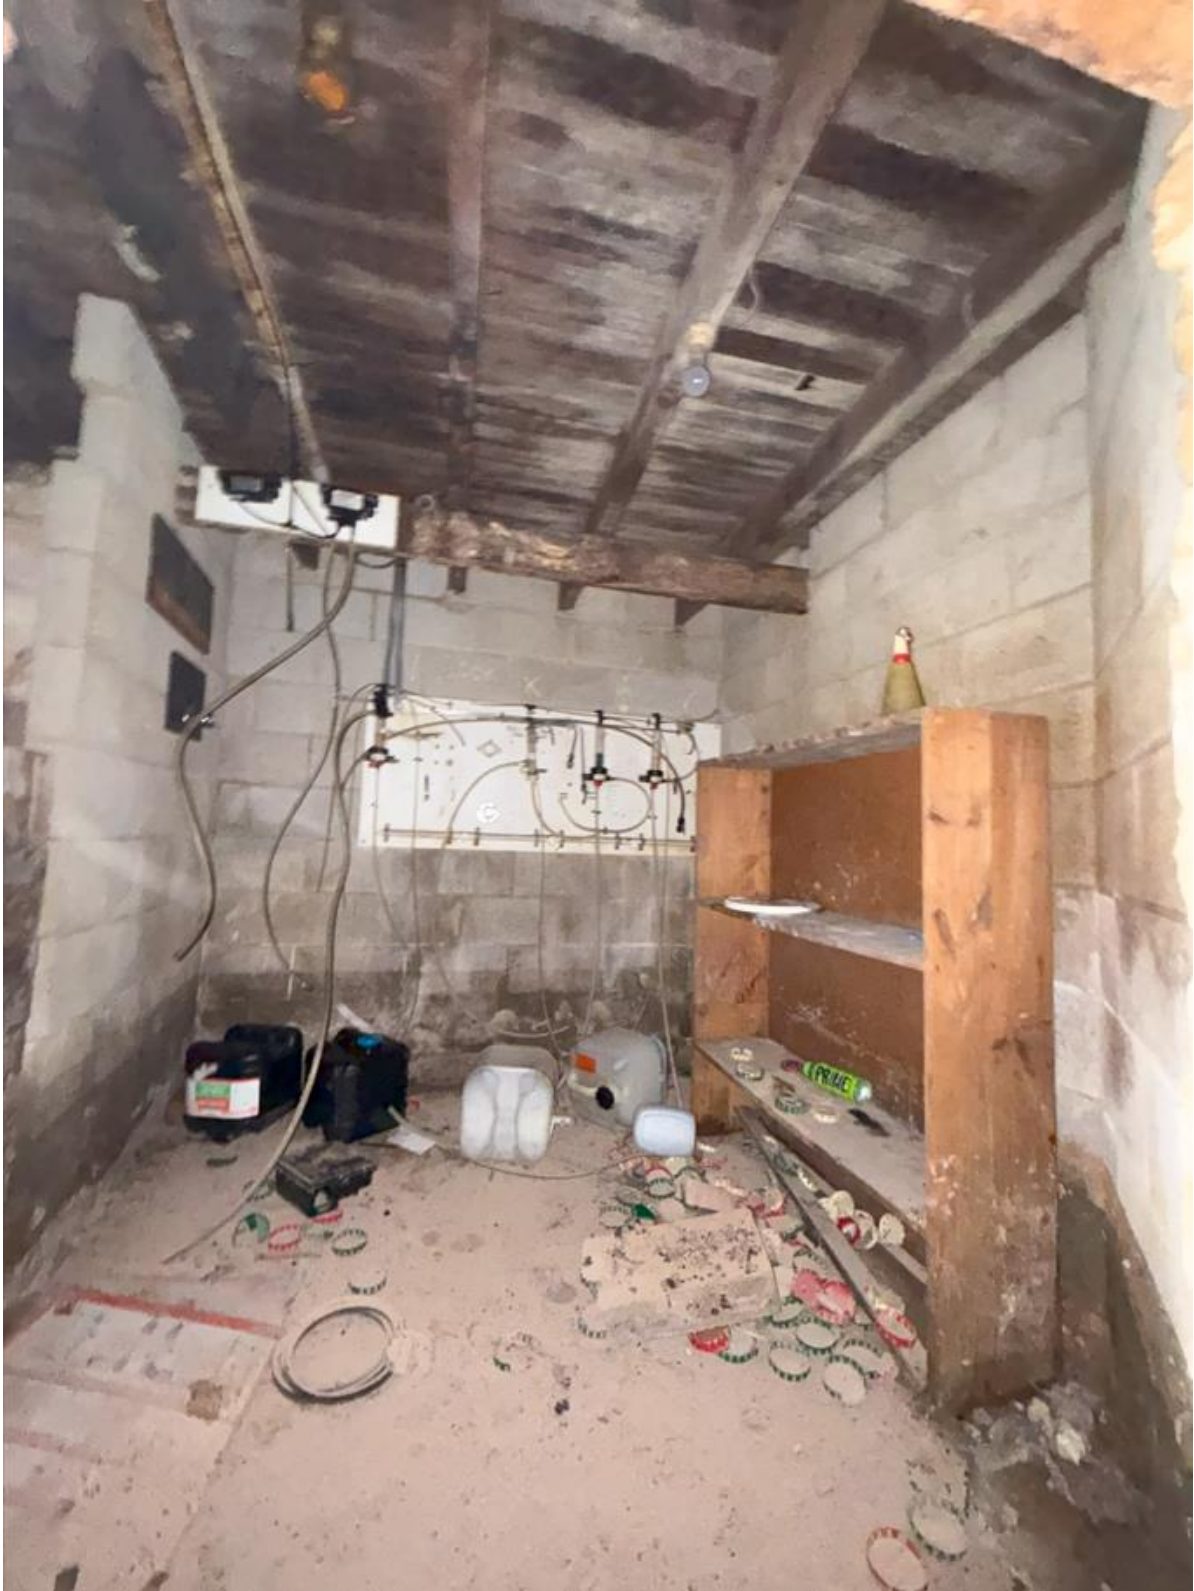
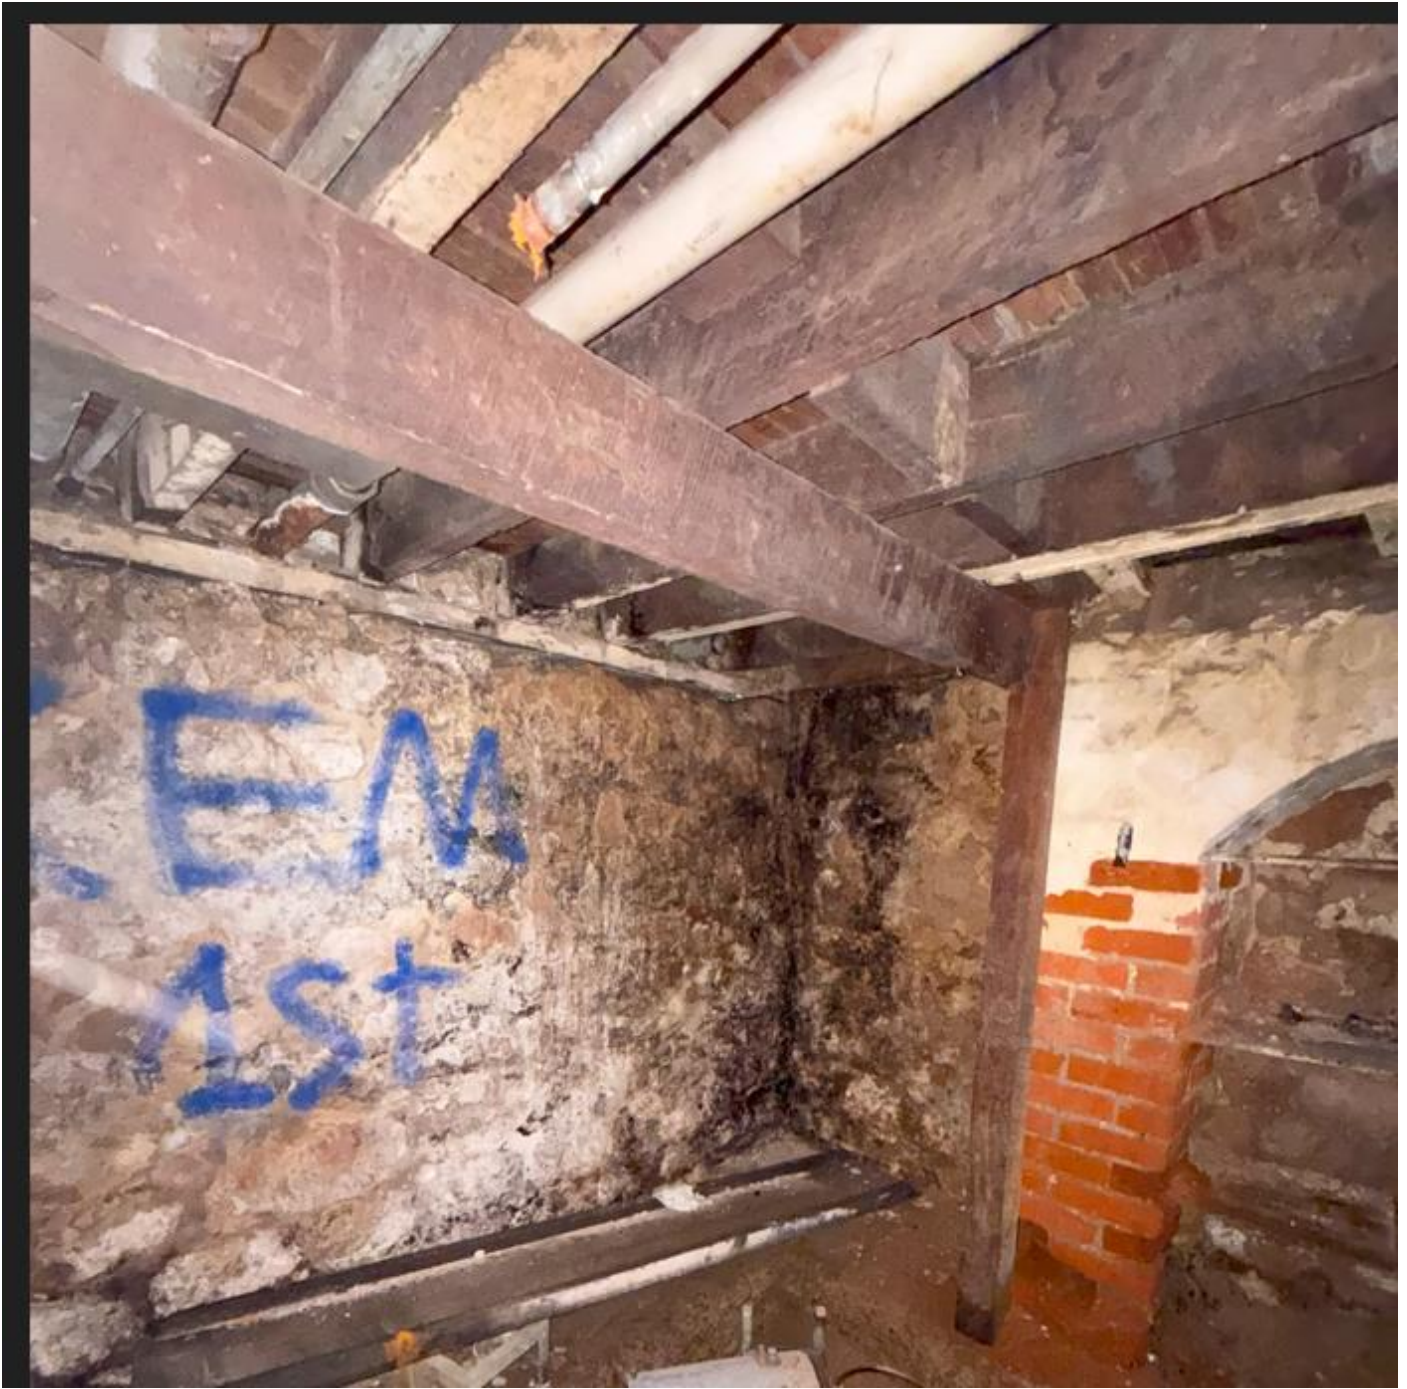
Existing basement cellar in zone 1 unaffected by the fire event as well.

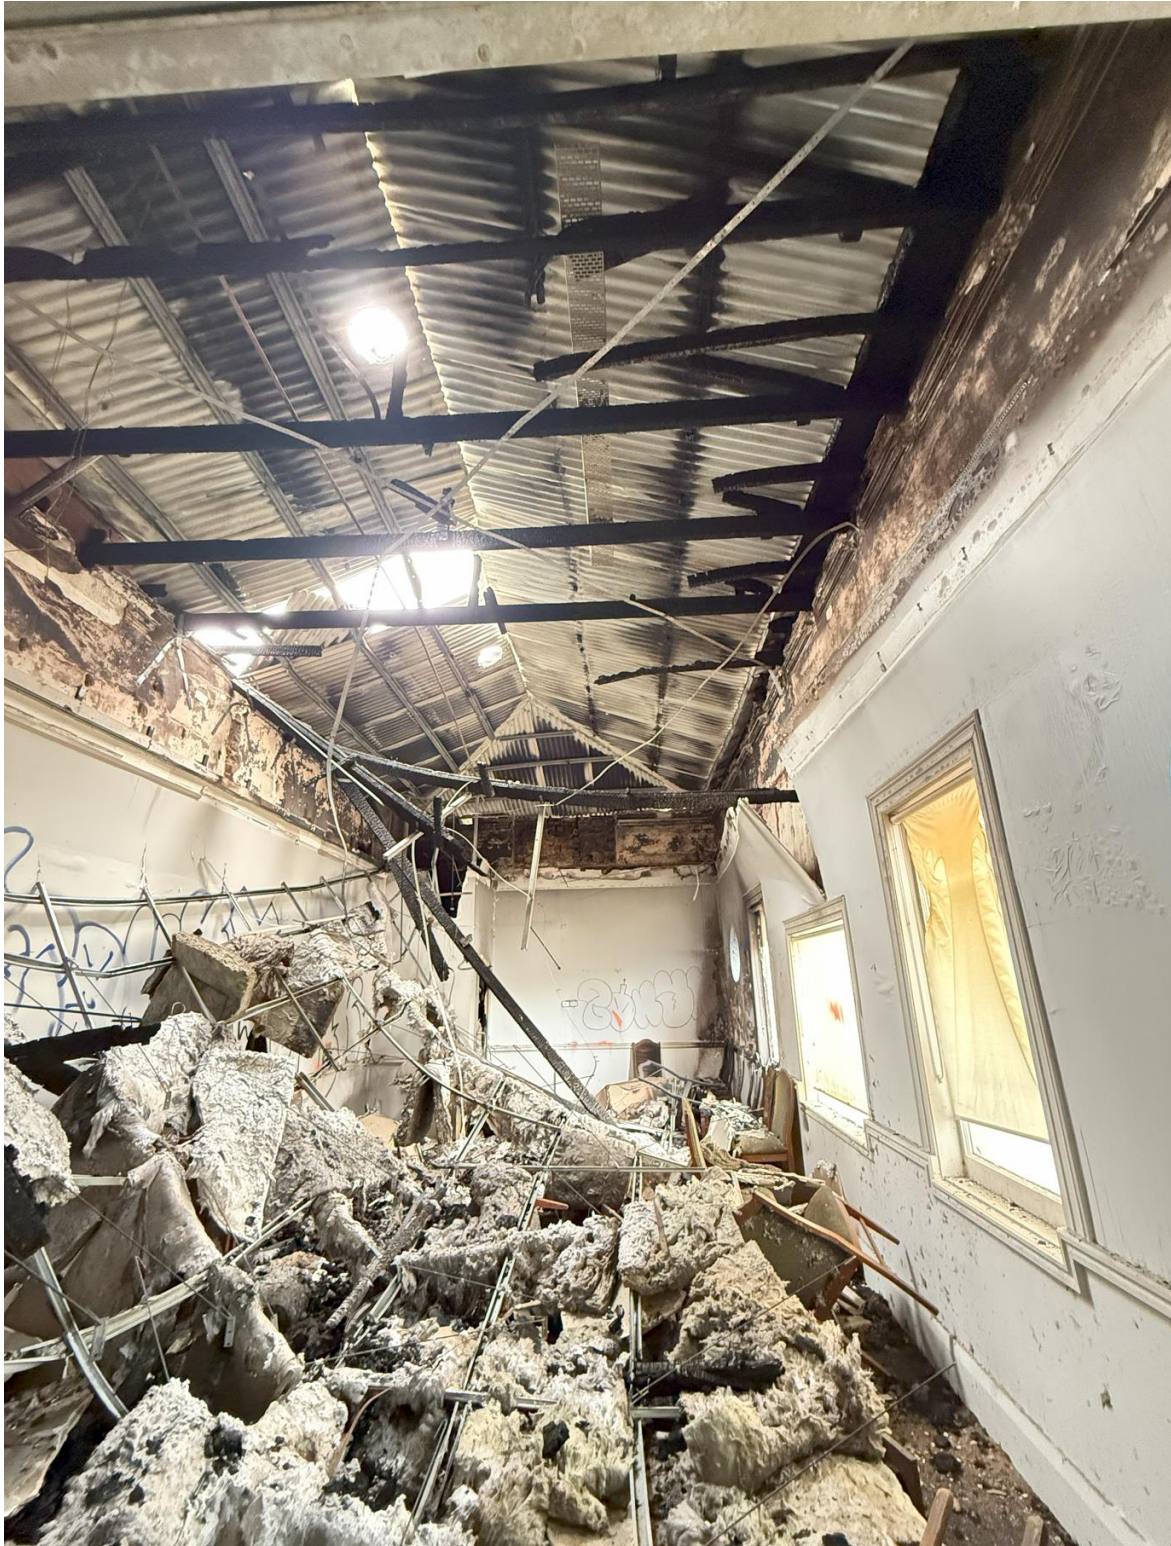
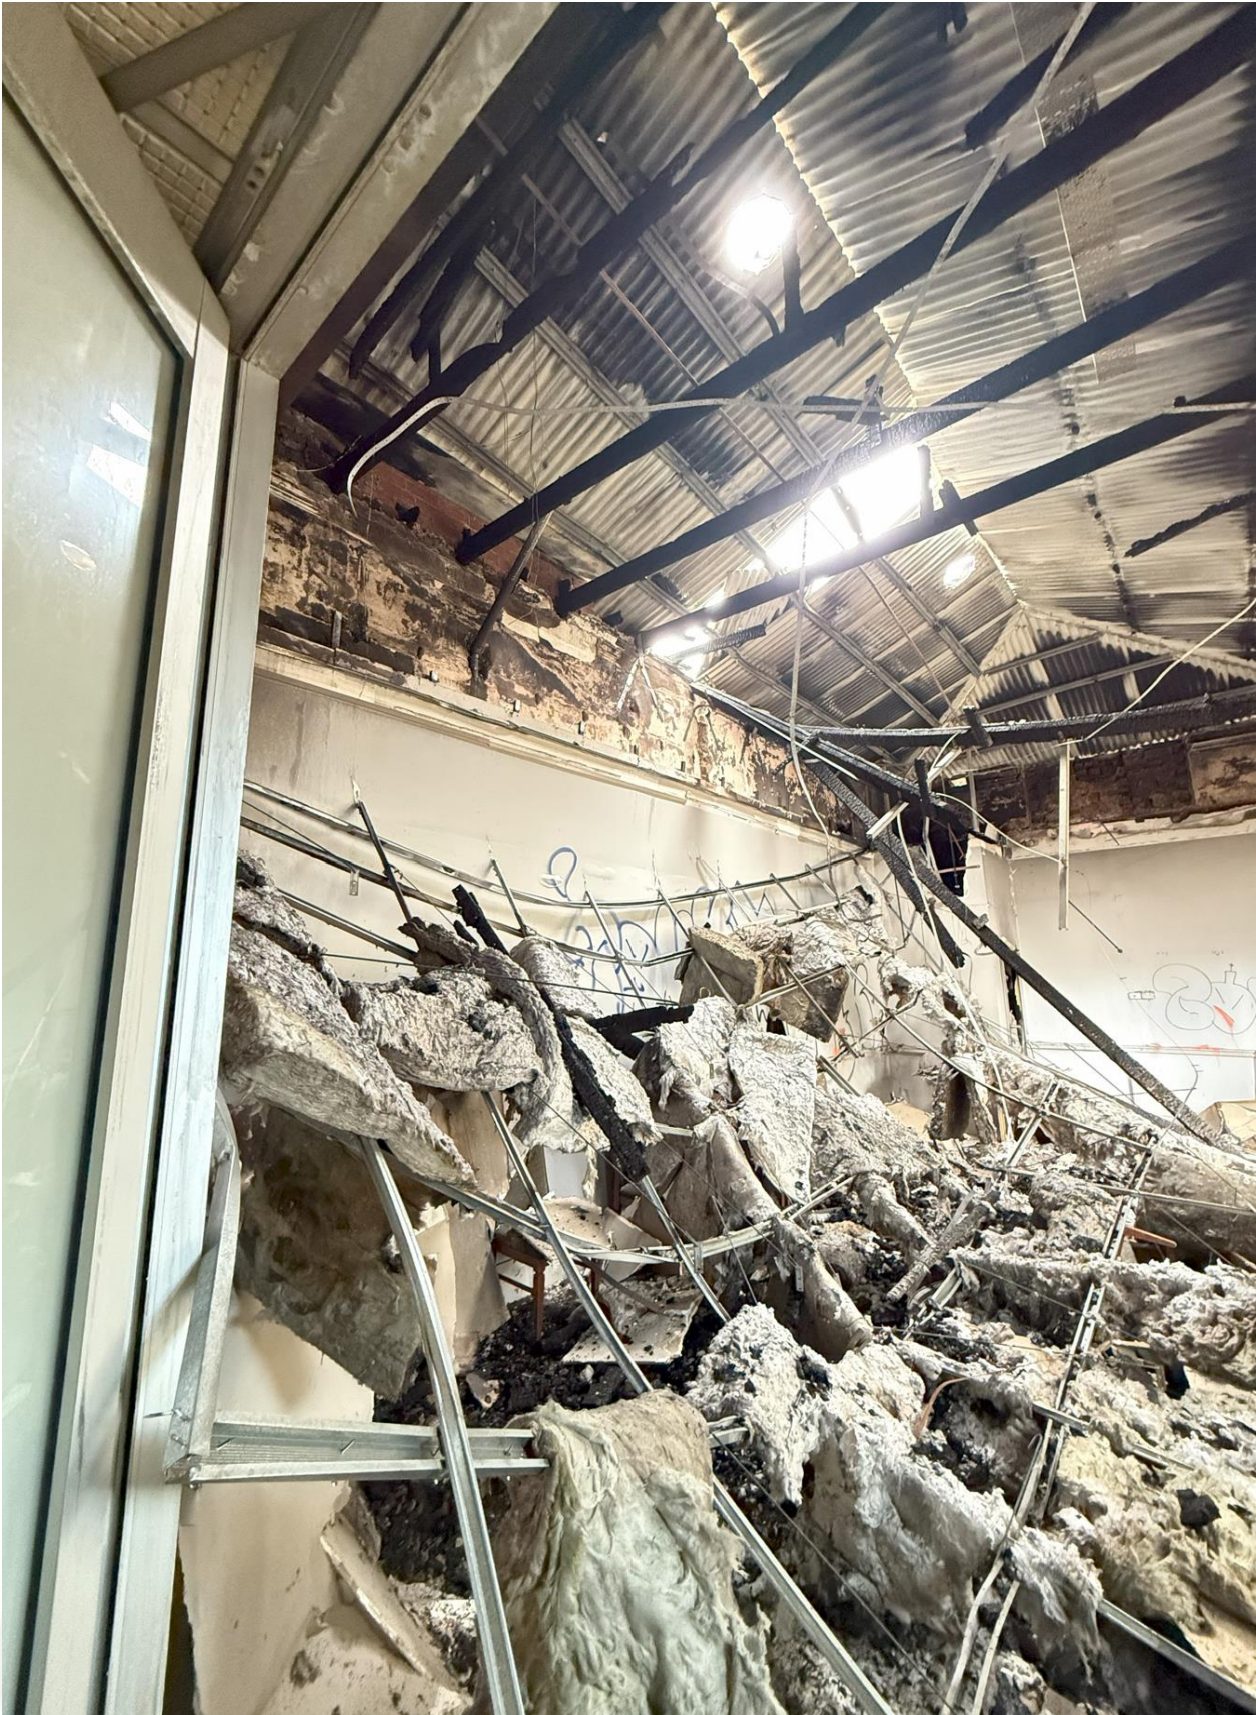
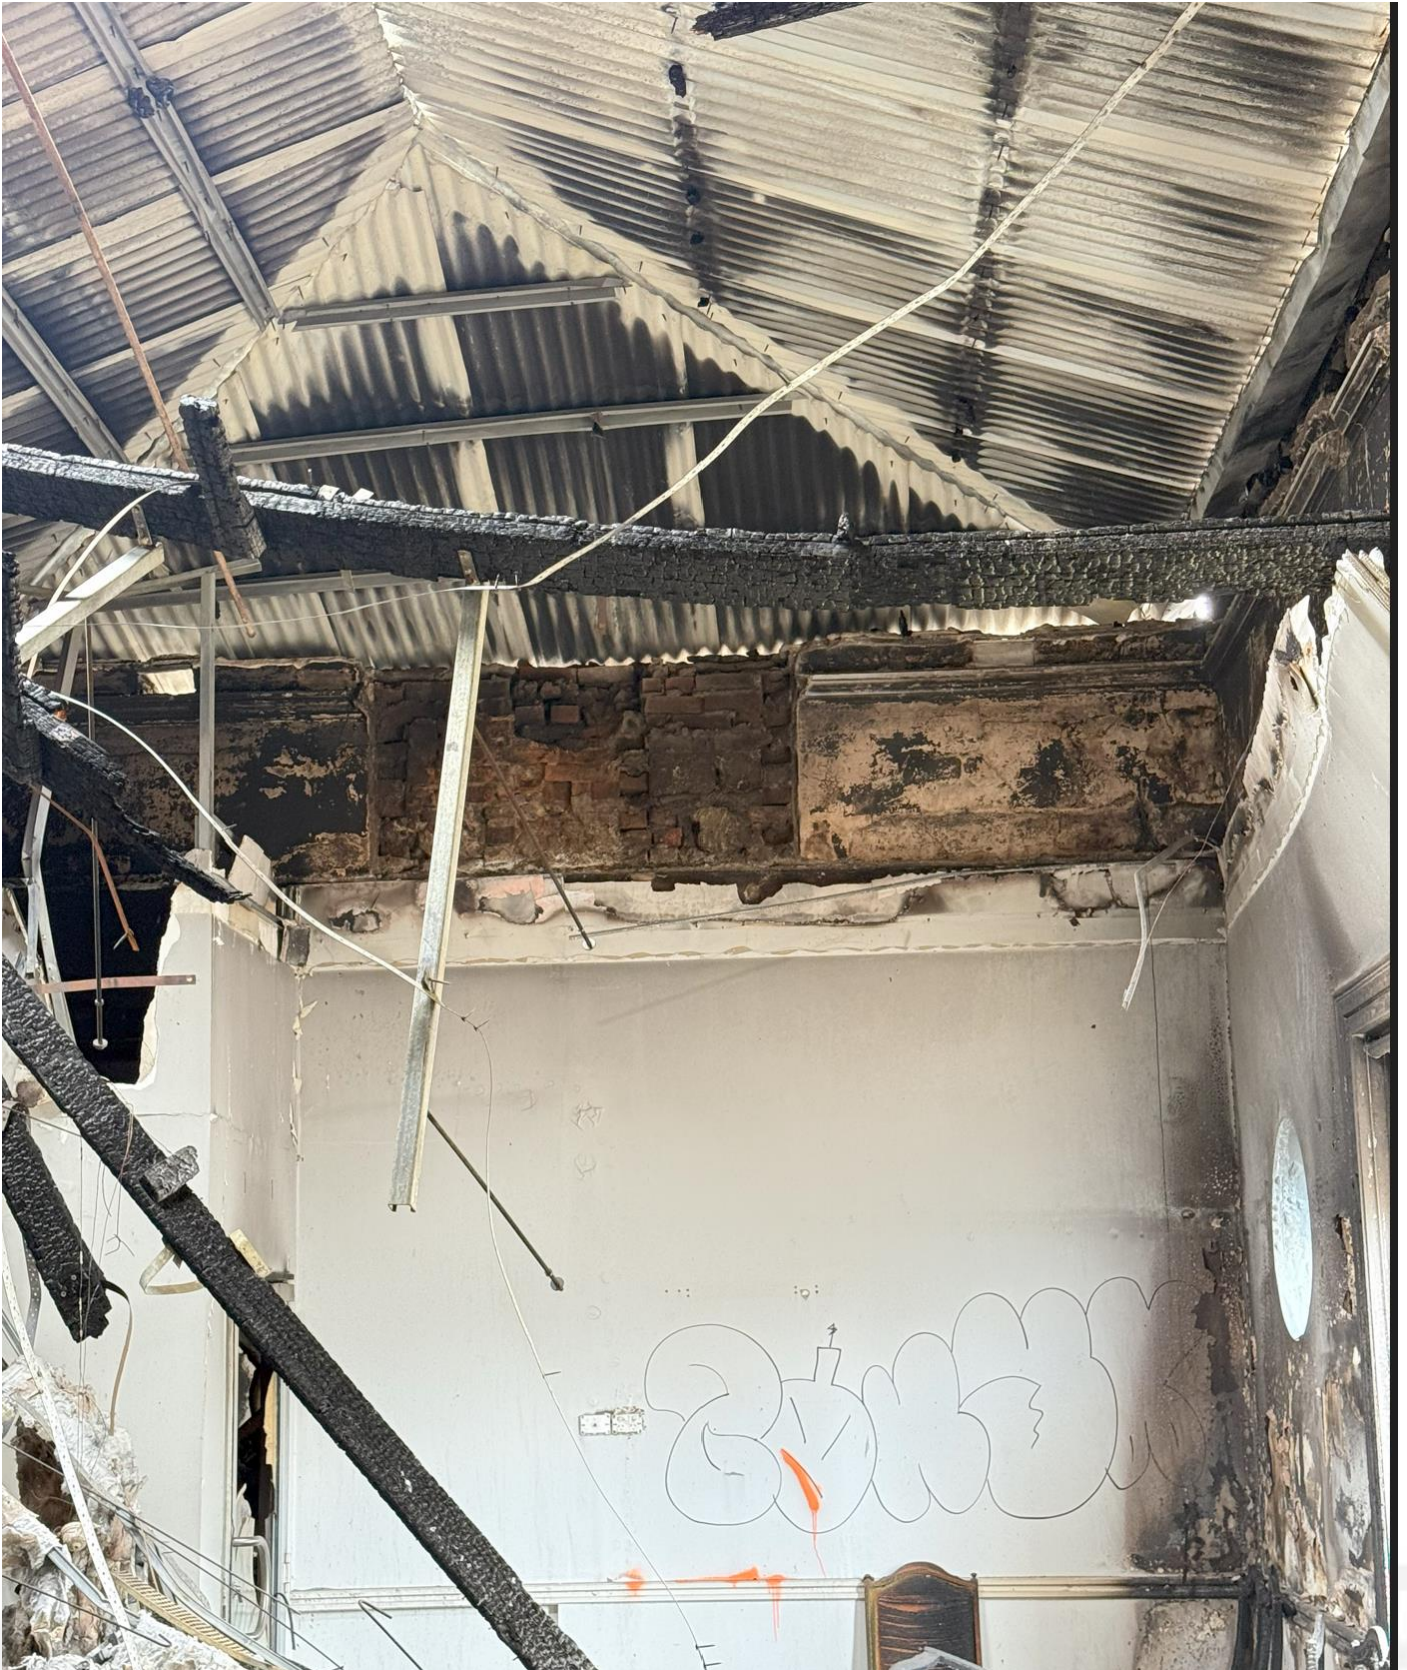
Condition of Building Segment to be retained – Zone 2

Ceiling and insulation has collapsed inwards, with roof rafters fully burned and charred

- A. In relation to the affected zone 2 area within the building segment that is proposed to be retained;
- Metal tin roof and supporting timber rafters to be fully replaced
  - Steel beam to be replaced with a new steel beam and column frame.
  - Existing walls within affected area interlock on all corners to form a self-stable and integral structure in current condition and do not require to be demolished.

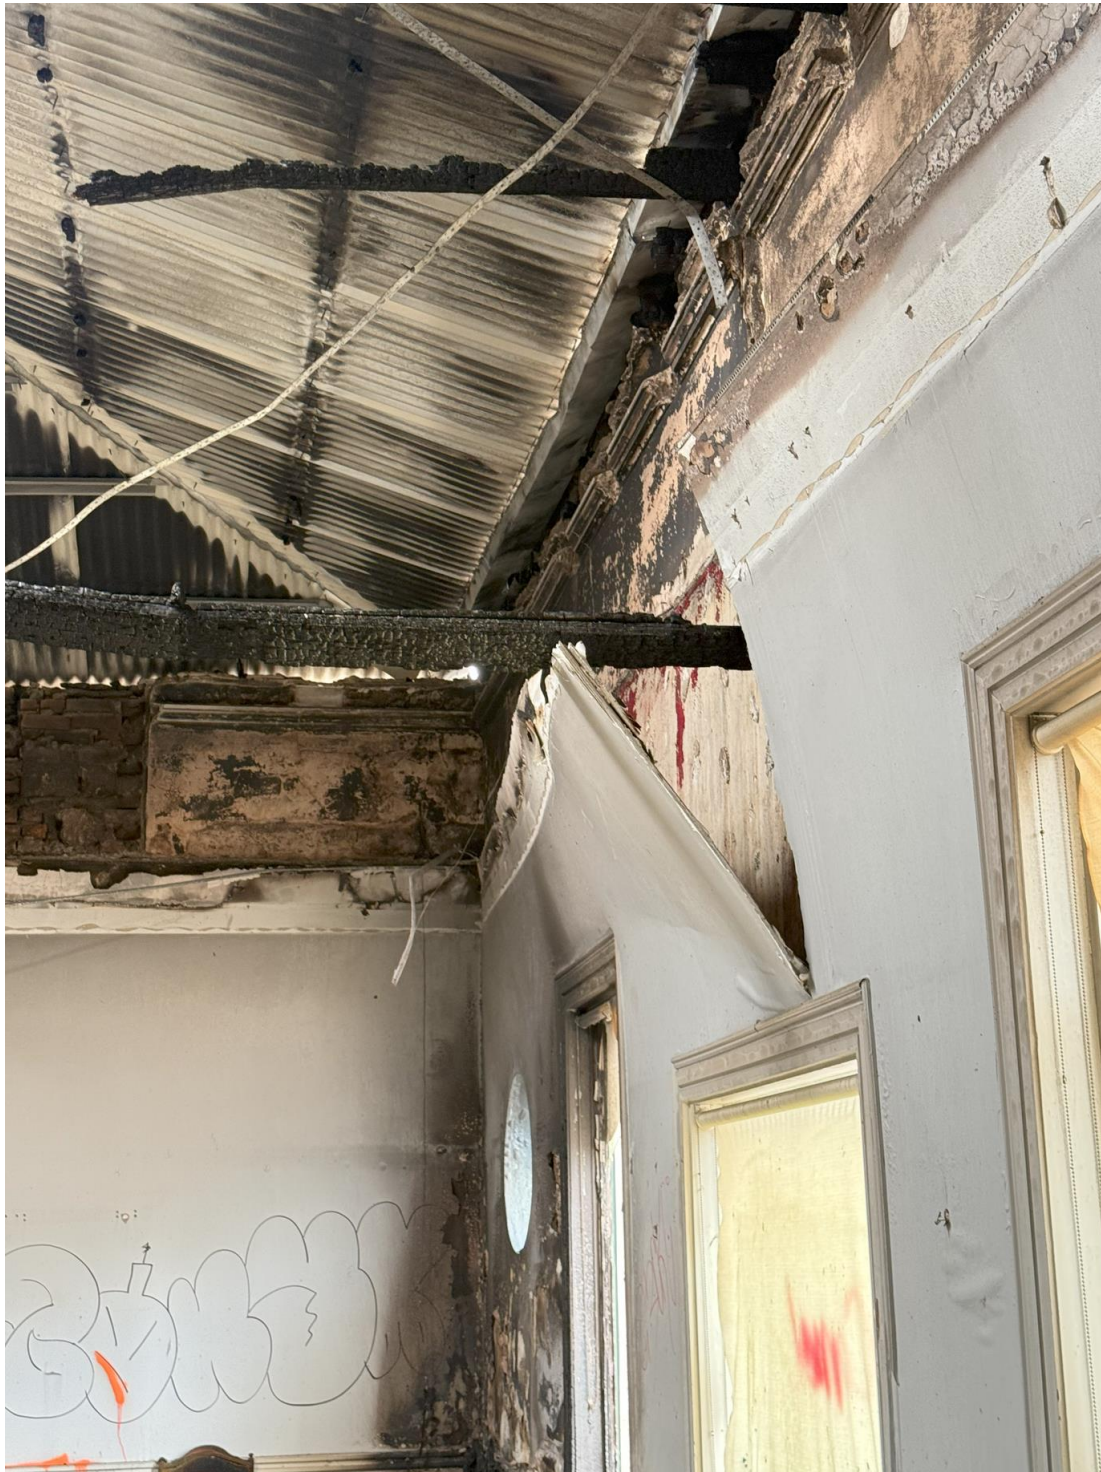
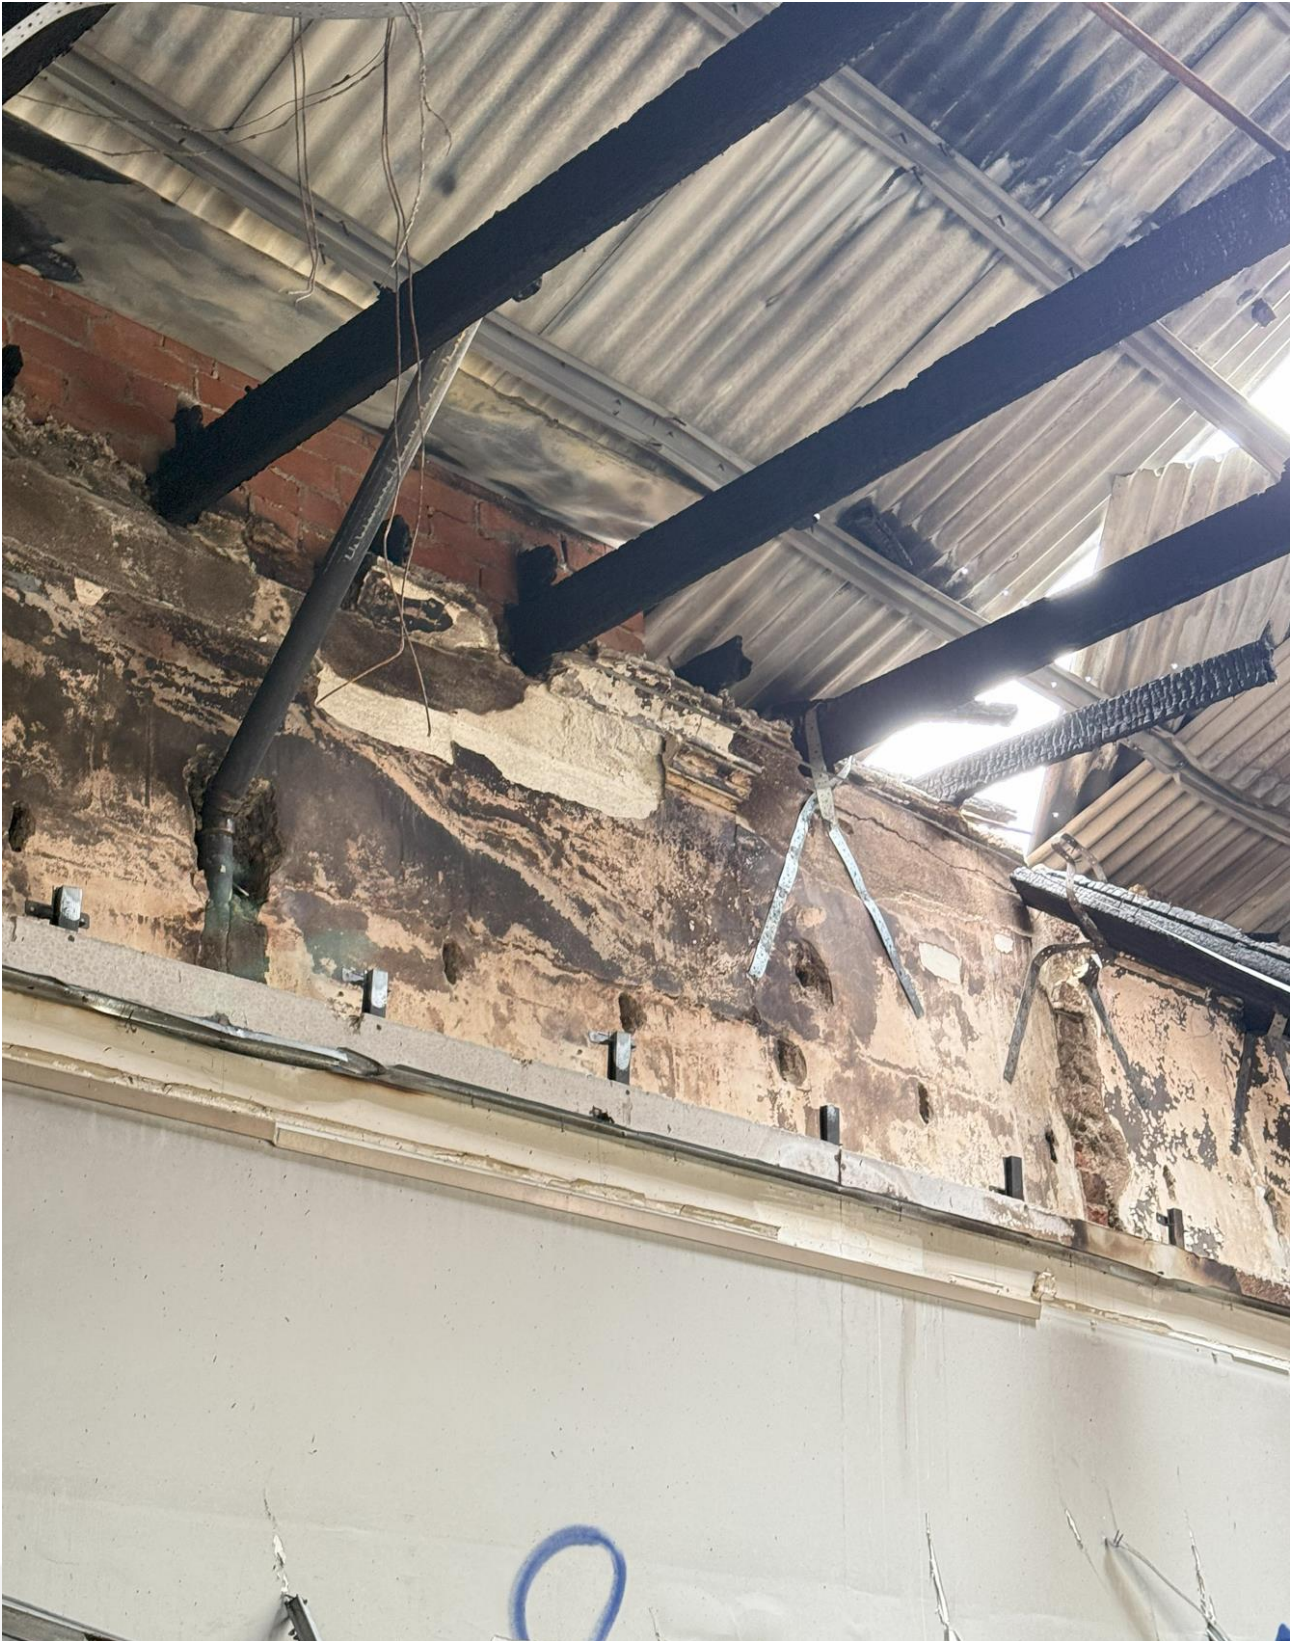
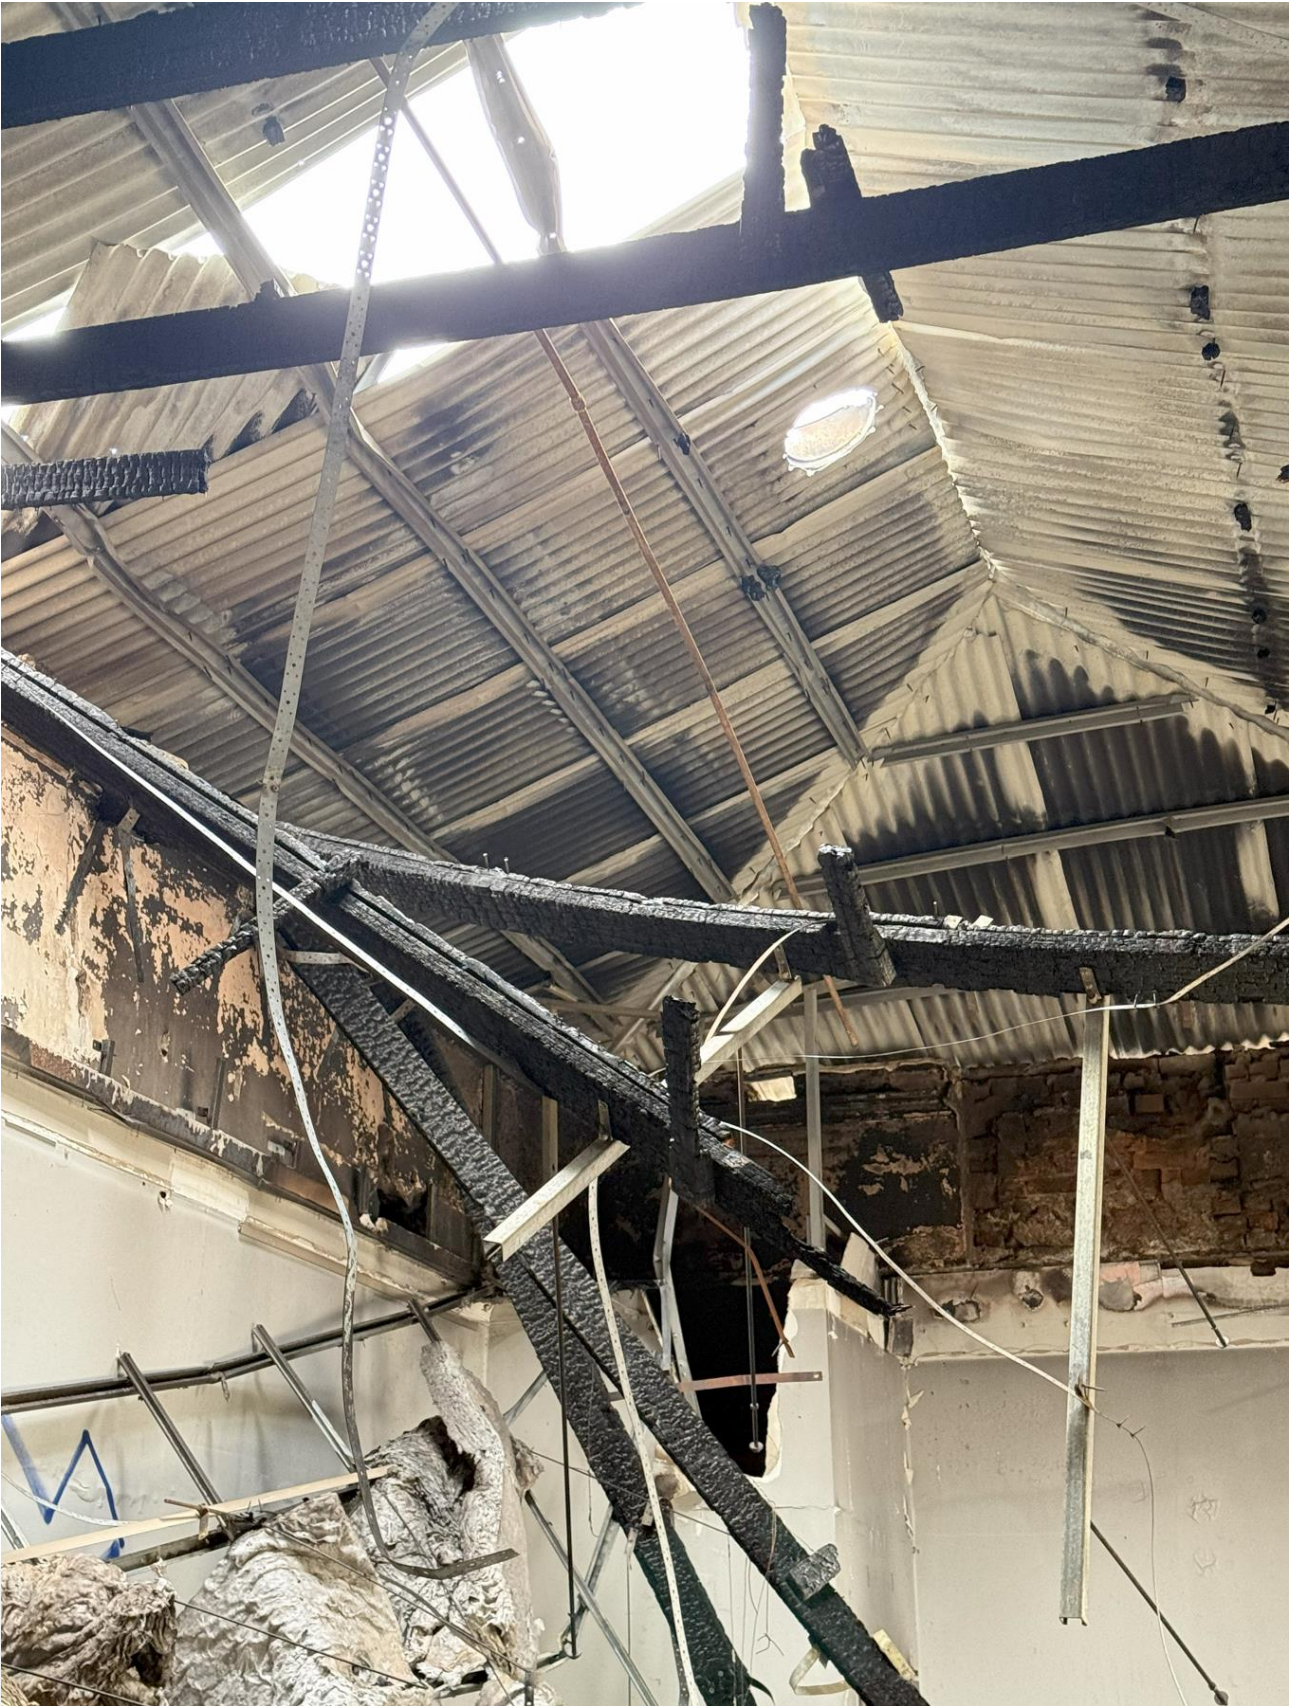
Walls remain intact and unaffected by the fire. Plaster render has delaminated due to the heat generated, but no visual signs of charring or burn onto the existing and proposed to be retained walls.

Note: The existing walls have been assessed based on 8.6m long x 5.2m wide construction, with minimum 220 thick interlocking solid brick construction and 3.5m clear height interlocking at all corners to form a box self-stabilizing structure as witnessed on site.

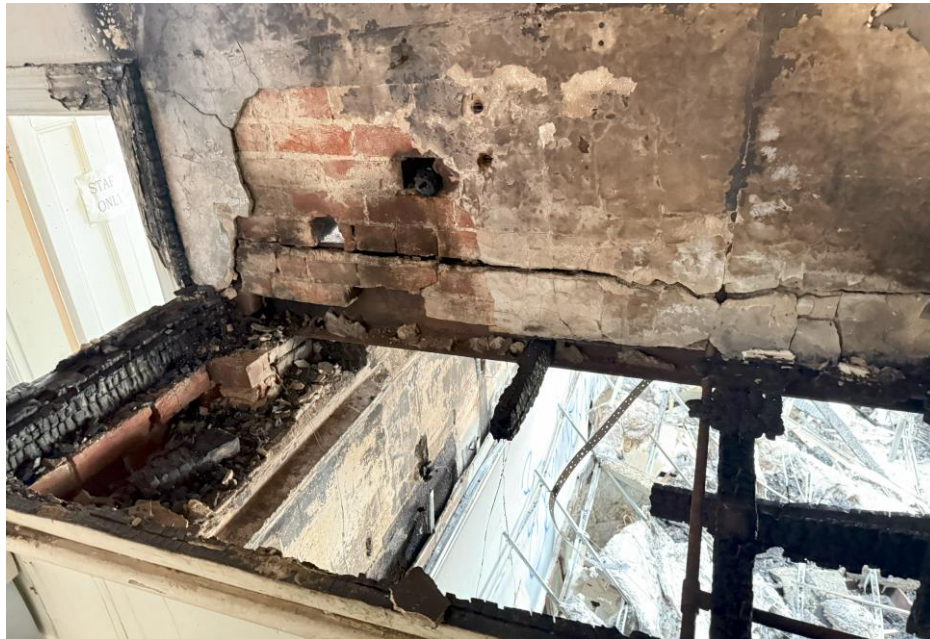
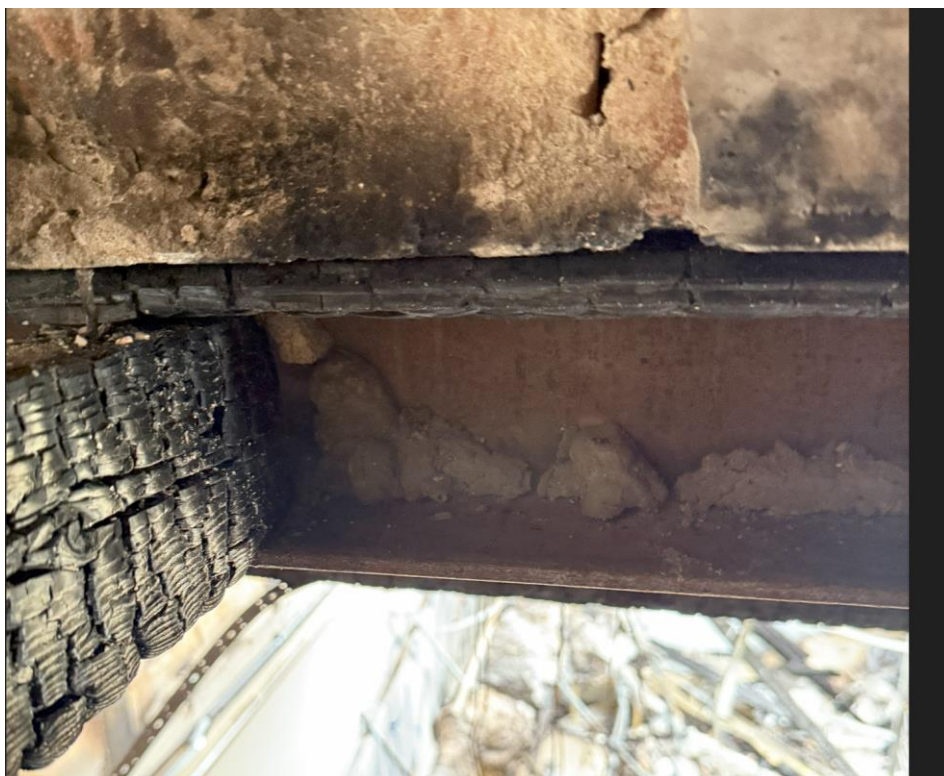
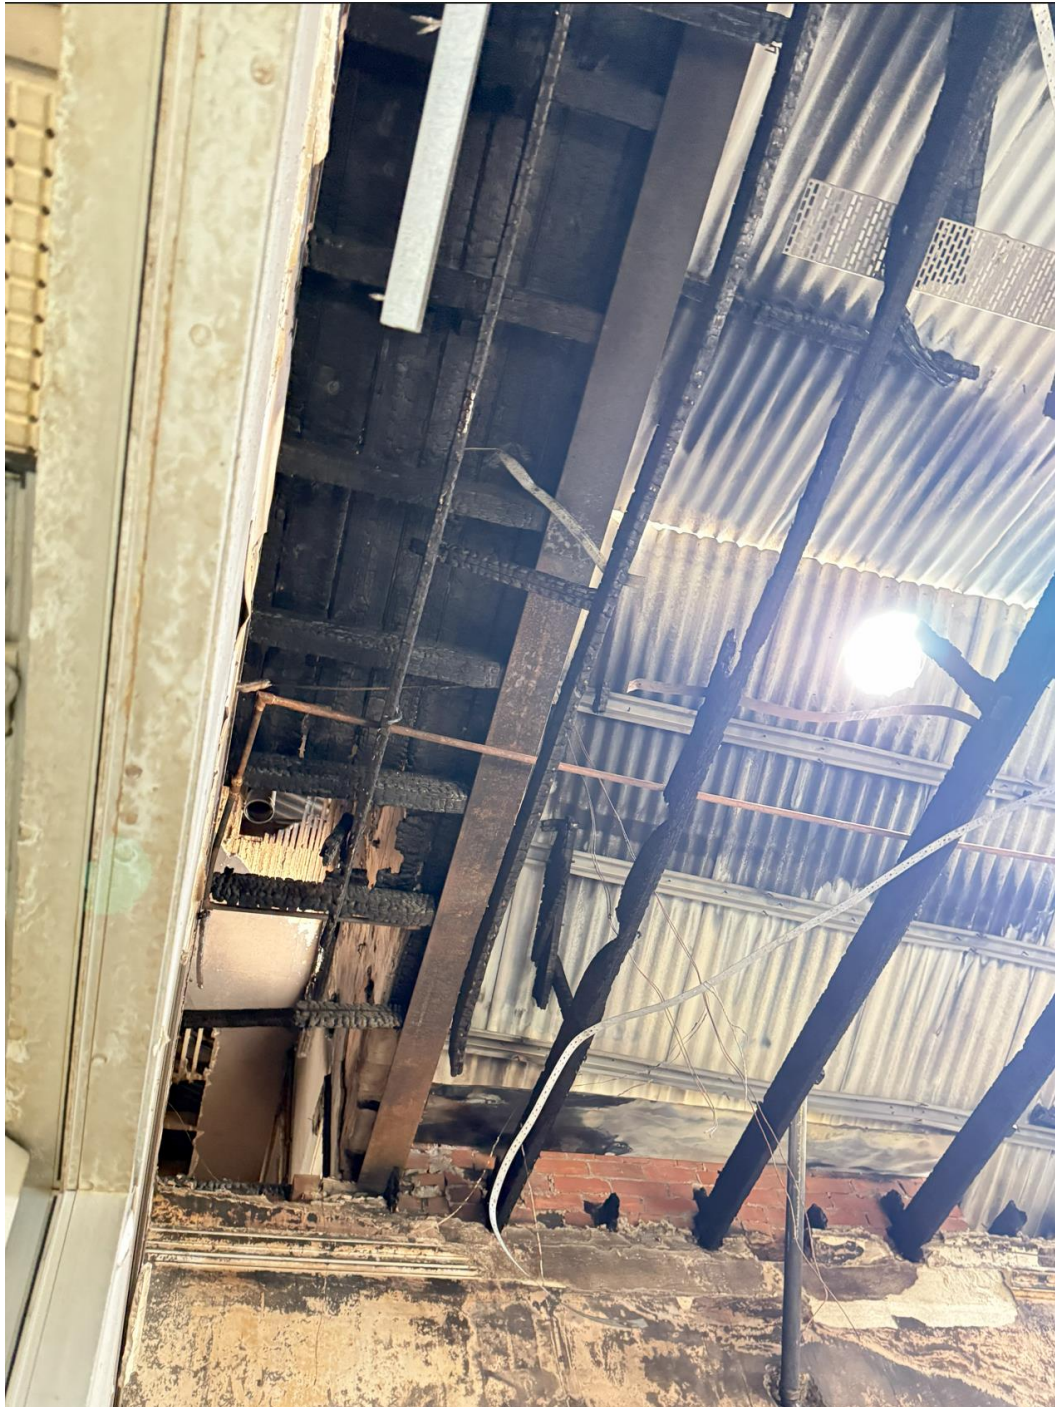
Steel beam remains intact with limited deformations or deflections, however adjoining timber rafters have charred and signs of heat/burn is visible on plaster and adjacent brick.

Hence, the steel beam is stable in its current condition however the ductility is assumed to have been affected by the heat generated during the fire event.
