Site: Buckingham Arms Hotel  
1 Walkerville Terrace  
Gilberton - S35706

### Addendum to Tree Assessment Report

# TREE ASSESSMENT

*S357076 Buckingham Arm Hotel Site - Citify Group*

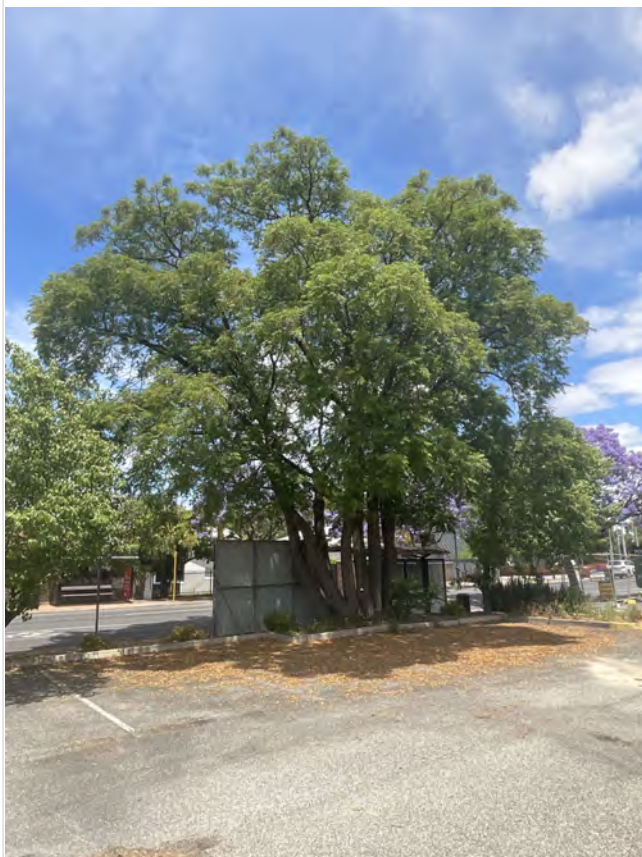
Date	Thu, 8 Dec 2022
Latitude	-34.9008967
Longitude	138.610016
ID Number	10

Age Class	Mature
Health	Good
Useful Life Expectancy	11+
Height	16
Structure	Average
Crown Dia. N/S	12
Crown Dia. E/W	12

Base Diameter (mm)	1.65710591
Structural Root Zone (m)	4.09
1m Circum. Total (mm)	5.76
1m Circum. Average. (mm)	1.152
Legislative Status	Significant
1.4m Diameter (mm)	1.79
Tree Protection Zone (m)	9.64

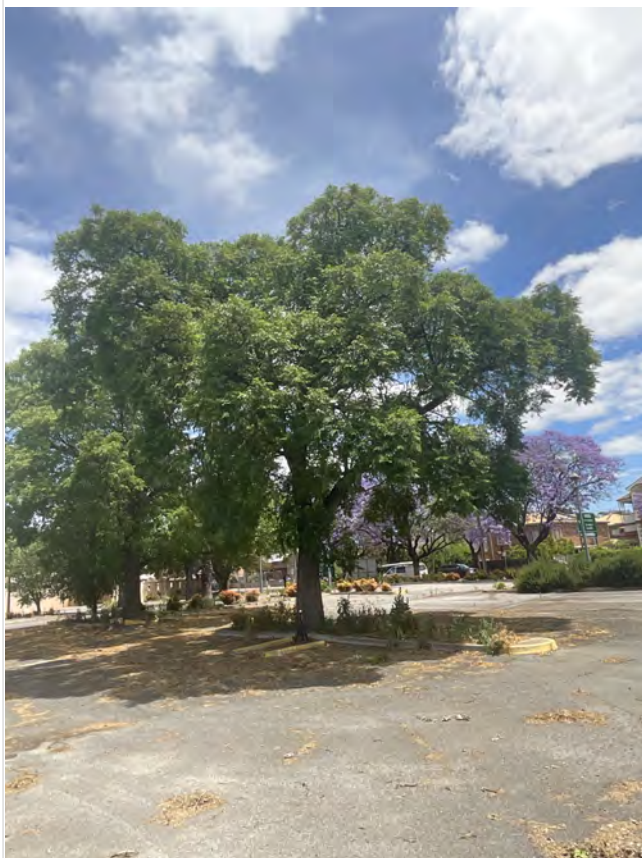
Date	Thu, 8 Dec 2022
Latitude	-34.9005405
Longitude	138.609696
ID Number	11

Age Class	Mature
Health	Good
Useful Life Expectancy	11+
Height	16
Structure	Good
Crown Dia. N/S	10
Crown Dia. E/W	12

Base Diameter (mm)	0.75
Structural Root Zone (m)	2.93
1m Circum. Total (mm)	2.12
1m Circum. Average. (mm)	2.12
Legislative Status	Regulated
1.4m Diameter (mm)	0.63
Tree Protection Zone (m)	7.56

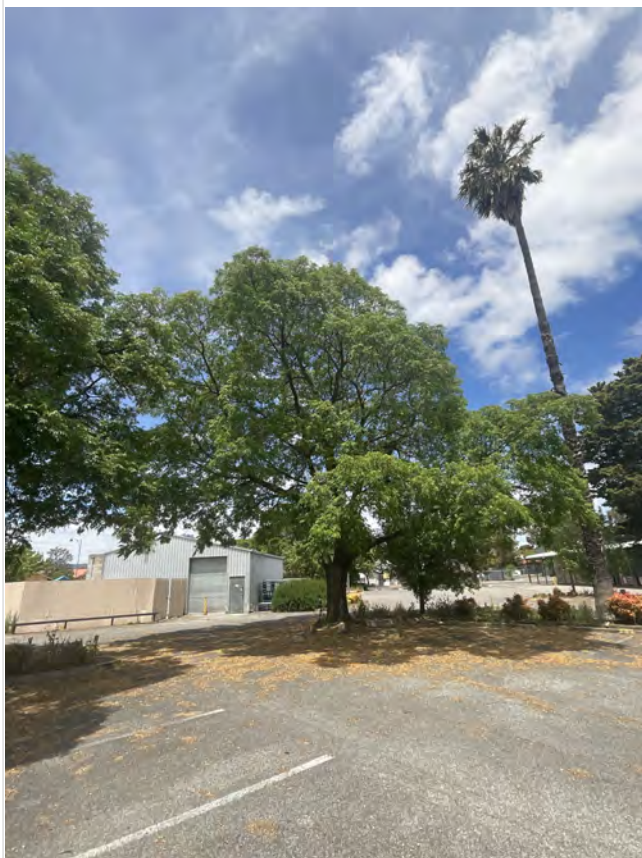
Date	Thu, 8 Dec 2022
Latitude	-34.9006377
Longitude	138.609665
ID Number	12

Age Class	Mature
Health	Good
Useful Life Expectancy	11+
Height	16
Structure	Good
Crown Dia. N/S	14
Crown Dia. E/W	12

Base Diameter (mm)	0.74
Structural Root Zone (m)	2.92
1m Circum. Total (mm)	2.12
1m Circum. Average. (mm)	2.12
Legislative Status	Regulated
1.4m Diameter (mm)	0.67
Tree Protection Zone (m)	8.04

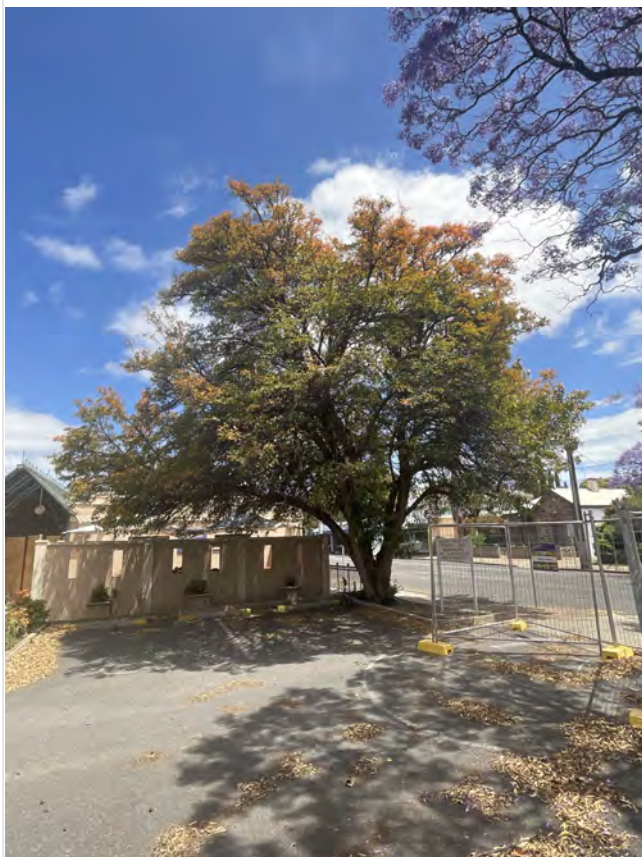
Date	Thu, 8 Dec 2022
Latitude	-34.9009745
Longitude	138.609407
ID Number	1

Age Class	Mature
Health	Fair
Useful Life Expectancy	11+
Height	16
Structure	Good
Crown Dia. N/S	10
Crown Dia. E/W	10

Base Diameter (mm)	0.80
Structural Root Zone (m)	3.01
1m Circum. Total (mm)	3.19
1m Circum. Average. (mm)	1.595
Legislative Status	Significant
1.4m Diameter (mm)	1.32
Tree Protection Zone (m)	8.54

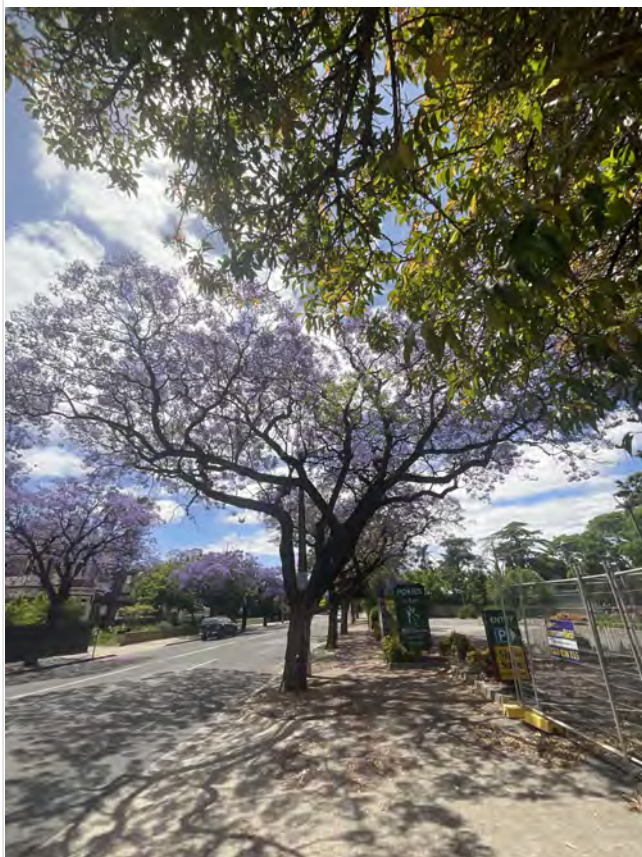
Date	Thu, 8 Dec 2022
Latitude	-34.9008722
Longitude	138.609348
ID Number	3

Age Class	Mature
Health	Good
Useful Life Expectancy	11+
Height	14
Structure	Good
Crown Dia. N/S	10
Crown Dia. E/W	14

Base Diameter (mm)	0.62
Structural Root Zone (m)	2.71
1m Circum. Total (mm)	.83
1m Circum. Average. (mm)	.83
Legislative Status	Exempt
1.4m Diameter (mm)	0.58
Tree Protection Zone (m)	6.96

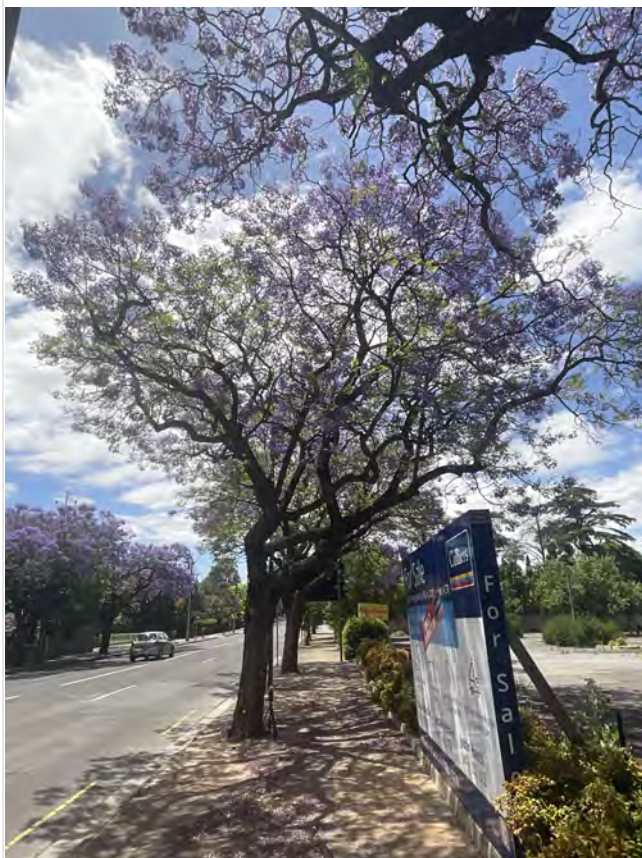
Date	Thu, 8 Dec 2022
Latitude	-34.9007795
Longitude	138.609322
ID Number	4

Age Class	Mature
Health	Good
Useful Life Expectancy	11+
Height	15
Structure	Good
Crown Dia. N/S	12
Crown Dia. E/W	10

Base Diameter (mm)	0.54
Structural Root Zone (m)	2.55
1m Circum. Total (mm)	1.55
1m Circum. Average. (mm)	1.55
Legislative Status	Exempt
1.4m Diameter (mm)	0.49
Tree Protection Zone (m)	5.88

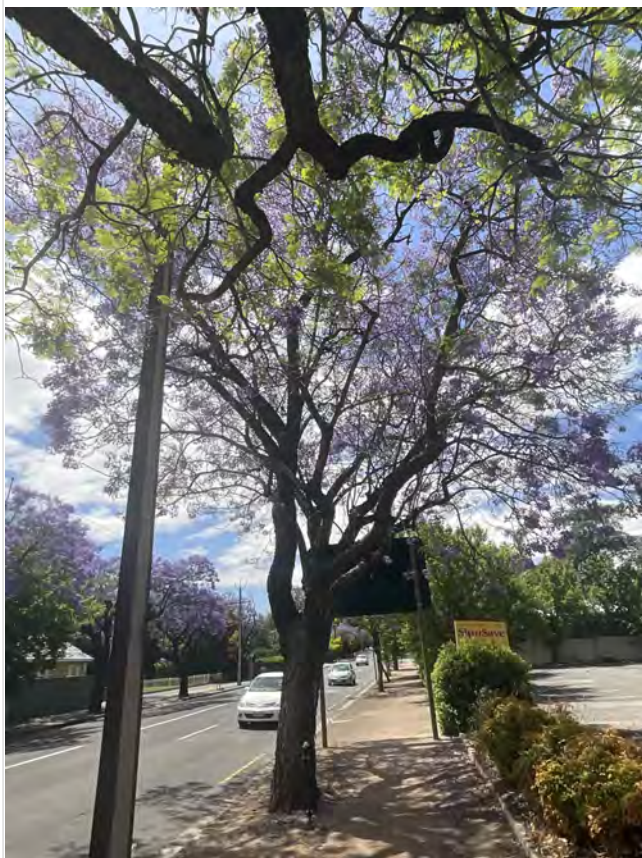
Date	Thu, 8 Dec 2022
Latitude	-34.9006985
Longitude	138.609327
ID Number	5

Age Class	Mature
Health	Good
Useful Life Expectancy	11+
Height	15
Structure	Good
Crown Dia. N/S	12
Crown Dia. E/W	12

Base Diameter (mm)	0.60
Structural Root Zone (m)	2.67
1m Circum. Total (mm)	1.7
1m Circum. Average. (mm)	1.7
Legislative Status	Exempt
1.4m Diameter (mm)	0.56
Tree Protection Zone (m)	6.72

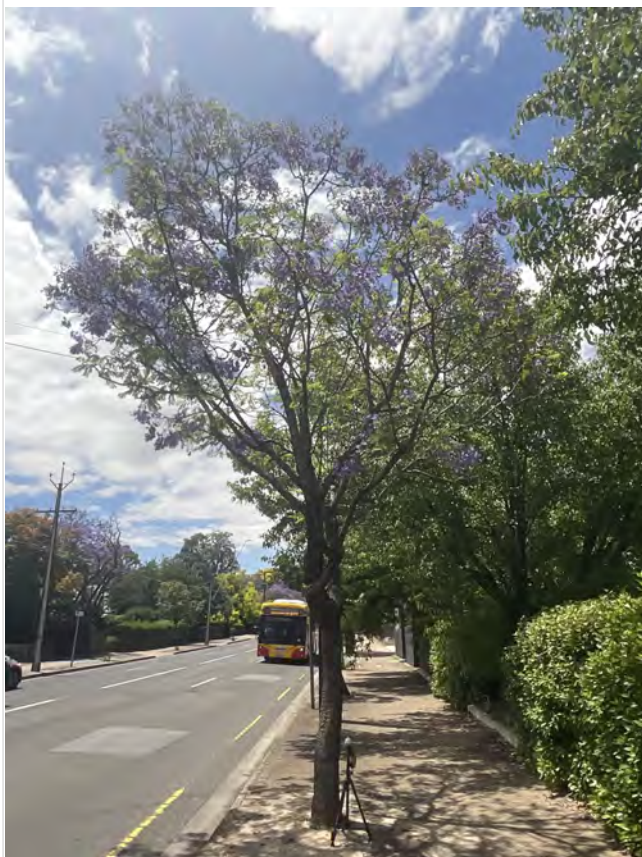
Date	Thu, 8 Dec 2022
Latitude	-34.9004763
Longitude	138.609322
ID Number	6

Age Class	Semi-Mature
Health	Good
Useful Life Expectancy	11+
Height	8
Structure	Good
Crown Dia. N/S	4
Crown Dia. E/W	3

Base Diameter (mm)	0.26
Structural Root Zone (m)	1.88
1m Circum. Total (mm)	.72
1m Circum. Average. (mm)	.72
Legislative Status	Exempt
1.4m Diameter (mm)	0.22
Tree Protection Zone (m)	2.64

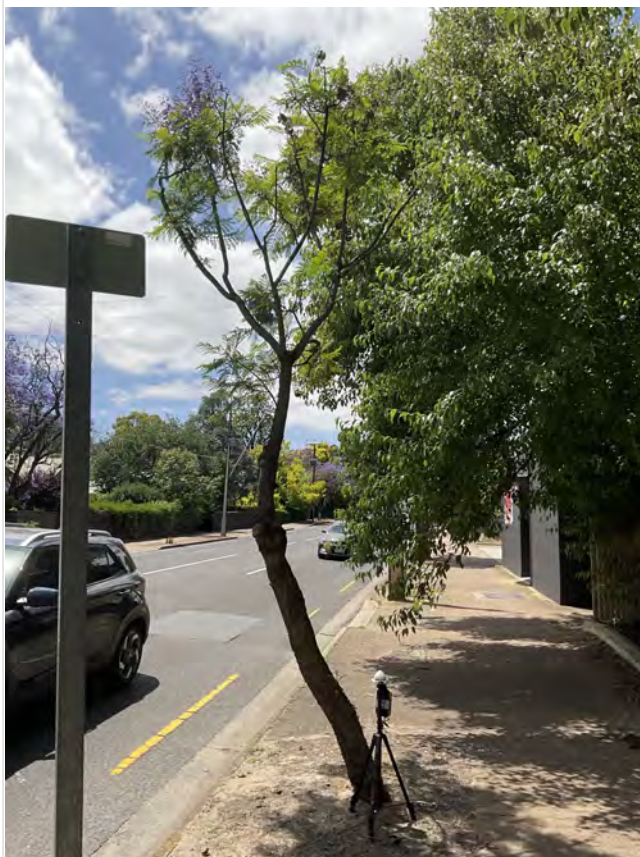
Date	Thu, 8 Dec 2022
Latitude	-34.9003598
Longitude	138.609316
ID Number	7

Age Class	Semi-Mature
Health	Fair
Useful Life Expectancy	3 - 10 Years
Height	6
Structure	Average
Crown Dia. N/S	1
Crown Dia. E/W	1

Base Diameter (mm)	0.18
Structural Root Zone (m)	1.61
1m Circum. Total (mm)	.48
1m Circum. Average. (mm)	.48
Legislative Status	Exempt
1.4m Diameter (mm)	0.14
Tree Protection Zone (m)	1.68

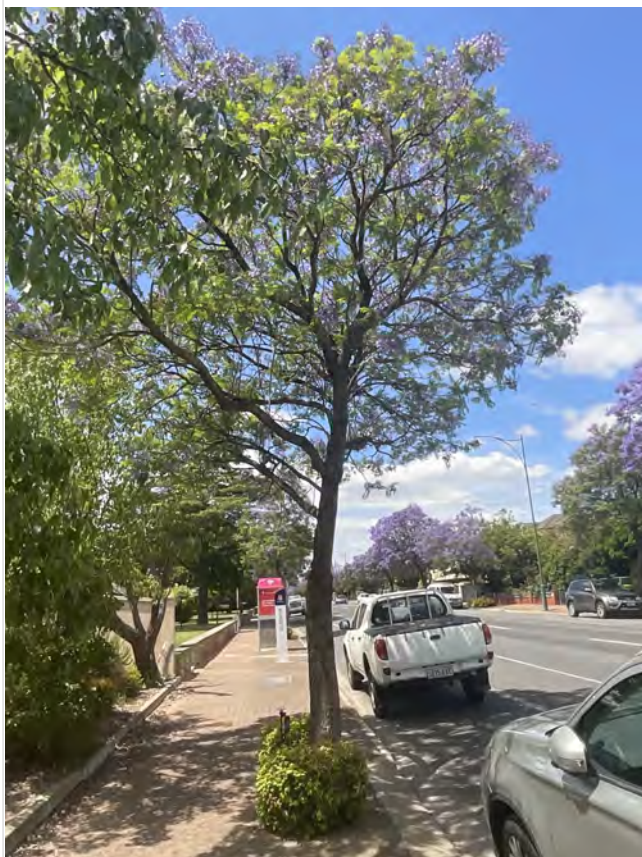
Date	Thu, 8 Dec 2022
Latitude	-34.9007903
Longitude	138.61017
ID Number	8

Age Class	Semi-Mature
Health	Good
Useful Life Expectancy	11+
Height	7
Structure	Good
Crown Dia. N/S	6
Crown Dia. E/W	4

Base Diameter (mm)	0.29
Structural Root Zone (m)	1.97
1m Circum. Total (mm)	.84
1m Circum. Average. (mm)	.84
Legislative Status	Exempt
1.4m Diameter (mm)	0.26
Tree Protection Zone (m)	3.12

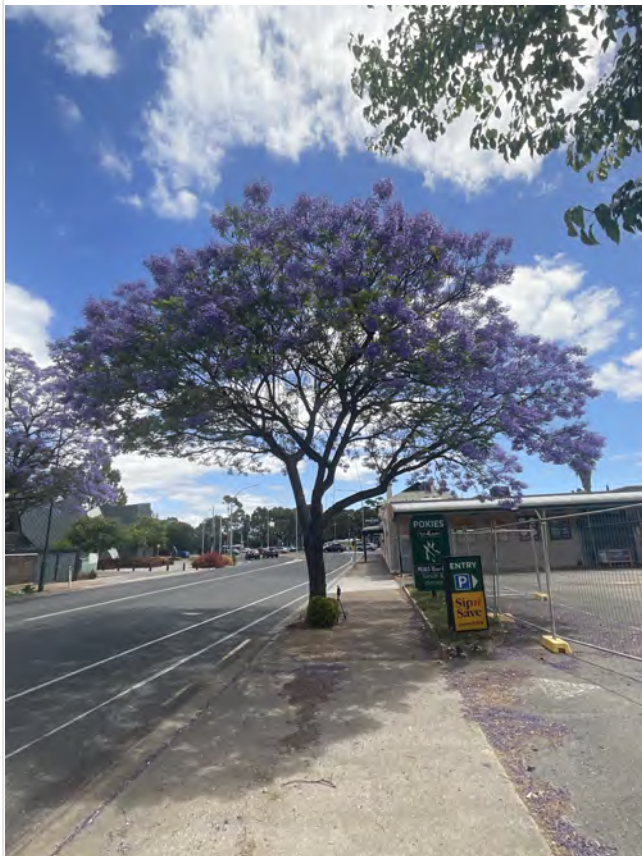
Date	Thu, 8 Dec 2022
Latitude	-34.9010133
Longitude	138.609945
ID Number	9

Age Class	Mature
Health	Good
Useful Life Expectancy	11+
Height	10
Structure	Good
Crown Dia. N/S	10
Crown Dia. E/W	12
