13 December 2024

Kent Cook  
Citify Group

## **RE: Buckingham Arms Hotel – Post-Fire Event Structural Assessment**

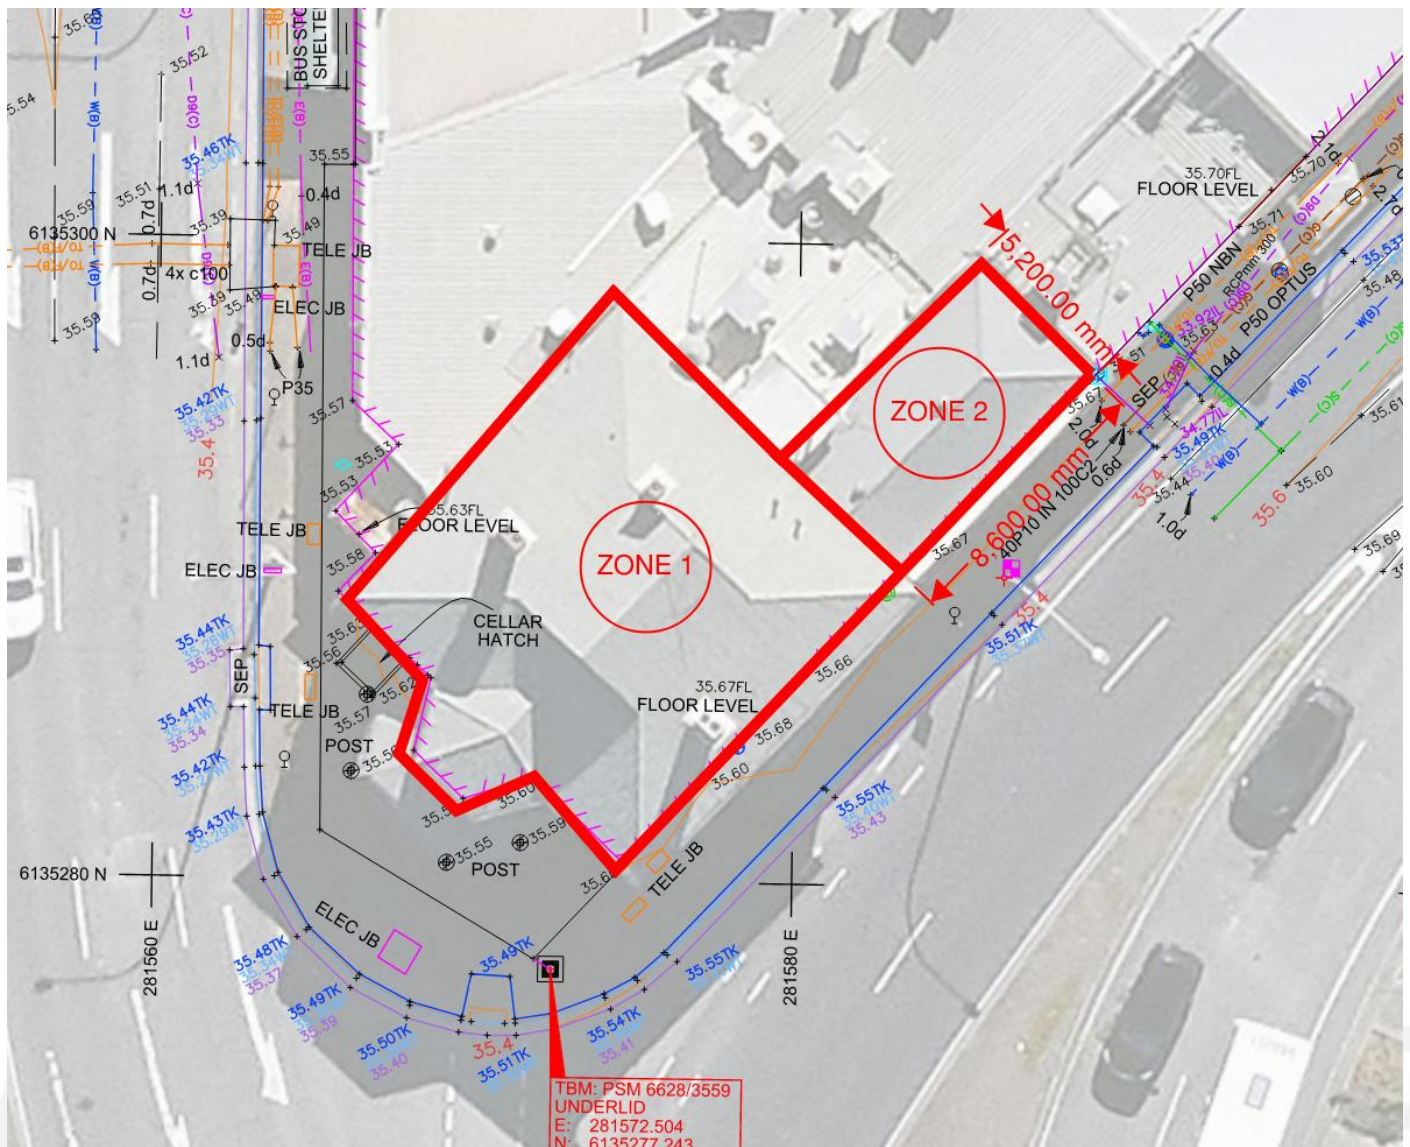
- The fire event did not impact the great majority of the heritage-listed building footprint that is proposed to be retained (zone 1)
- The fire event did affect the area below (zone 2) as following;
  - o Tin roofing is damaged/burned and requires replacement
  - o Roof timber purlins are damaged/burned and required replacement
  - o Perimeter masonry walls are unaffected with only minor charring of the plaster finish
  - o Steel lintel beam supporting level 1 façade wall is likely to be impacted by the heat generated during the fire event although remains intact.
